# Assessment and Management of Existing Bridges Following the Innovative Italian Guidelines: A Pilot Study

**Abstract:** In 2022, the Italian Government introduced innovative regulations for evaluating and monitoring existing bridges and viaducts, tackling issues related to risk classification, safety assessment, and monitoring. These regulations employ a multilevel approach for bridge inspections, safety assessments, and monitoring procedures. The guidelines have garnered international acclaim for their forward-thinking approach. This paper proposes a comprehensive study concerning the whole process proposed in the new Italian guidelines, using a case study constituted by two prestressed RC box-girder half-joint span bridges that exhibited signs of aging several years ago. The paper deeply addresses all phases of the existing bridge safety assessment and management discussed in the guidelines from both a scientific and practical standpoint, in collaboration with the national agency for road administration. It starts with visual inspections conducted to support the bridge safety assessments and concludes with the experimental testing and structural monitoring of bridges. The objec

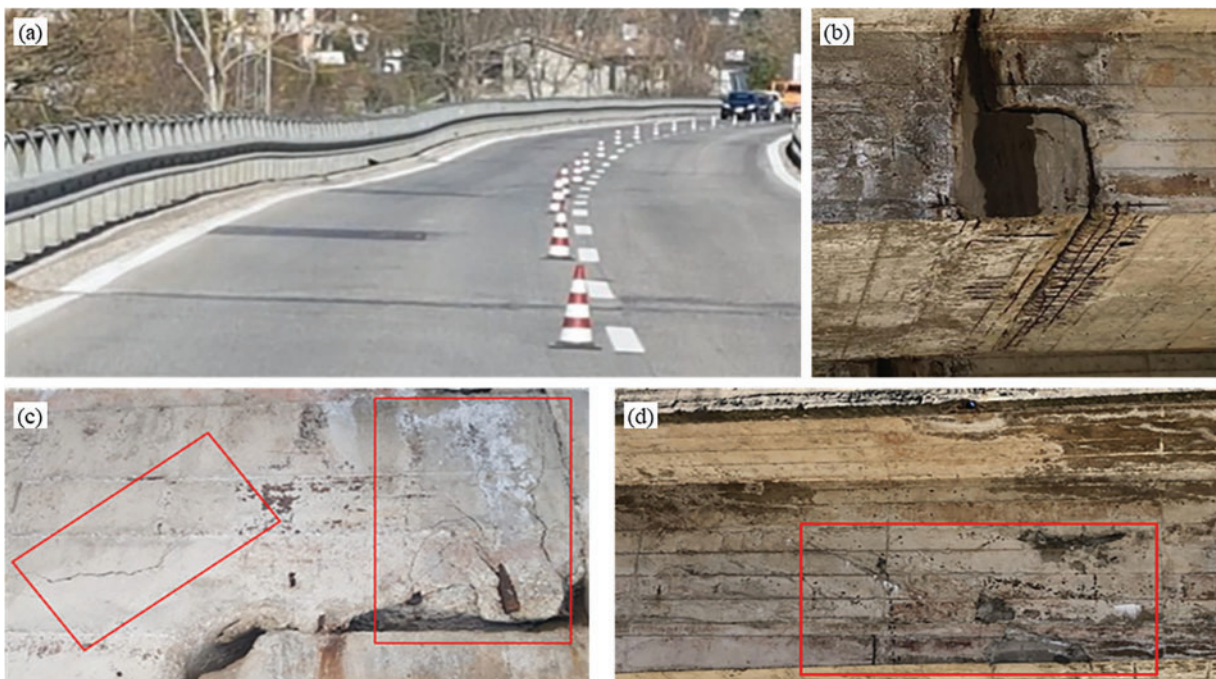
water infiltration through non-sealed pavement joints and damaged drainage systems. These defects included traces of both active and passive humidity, concrete degradation,

oxidation, and corrosion of reinforcements. Additionally, concrete spalling in areas subjected to humidity and drying cycles was detected as well, e.g., in the cantilevered

portion of the concrete slabs. In correspondence with the Gerber spans (spans 3, 4, and 5), an evident permanent deflection was observed (Fig. 3a) with a greater lowering at span 4 of both bridges, presumably related to concrete creep and/or excessive loss of prestress in combination with poor concrete quality. This lowering exposes the structures to significant dynamic effects deriving from the passage of heavy vehicles, potentially increasing fatigue effects on the structures. Moreover, the half-joints and the post-tensioning system exhibited defects such as (i) the complete gap closure at the half-joints (Fig. 3b), resulting in the development of an inner and undesirable stress state on the deck, (ii) the presence of moisture traces and white efflorescence along the longitudinal path of the prestressing cables (Fig. 3d), which could be attributed to water infiltration within the ducts or at the interface between ducts and concrete, (iii) and the presence of cracks close to the half-joints (Fig. 3c) at the inner corner of the nib and the lower corner of the nib full-depth interface, similar to those associated with half-joint collapse mechanisms reported in the literature.<sup>31,32</sup> Also, the DB showed an important deformability of the cantilever beams of span 4 under heavy vehicular traffic and, in the cracked half-joint, the opening and closing phenomena of cracks on the lateral side of the box-girder were noted during the passage of heavy vehicles, also producing noise and concrete dust fall.

**Figure 3.** Defects detected during the visual inspections: (a) permanent lowering of span 4, (b) defects of the half-joints, (c) cracks in correspondence of the half-joints, (d) efflorescence along the longitudinal path of the prestressing cables

Based on visual inspection outcomes (and also on safety verification outcomes, as will be shown in the sequel), the road administrator decided to close the DB and move the relevant traffic to the UB to guarantee at least one traffic lane in each direction of the route. As a result of this decision, monitoring actions were considered for the UB to improve the understanding of the bridges’ behavior and to support decisions regarding the use of the open bridge in the transitory period.

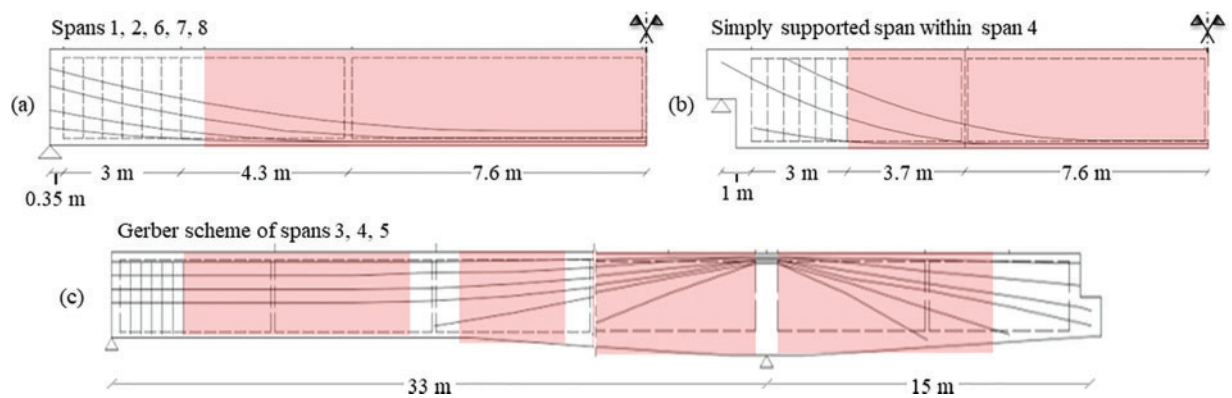
A summary of the verification outcomes is illustrated in Fig. 5, where red areas are used to identify those sections of the deck where at least one of the aforementioned verifications is not satisfied. If some verifications are not fulfilled considering the adequate bridge conditions, they should be repeated considering less severe situations, such as operational or even transitable bridge conditions. The former approach uses codified movable loads with adjusted safety factors, while the latter restricts bridge use and allows for less demanding movable loads with adjusted safety factors. Retrofitting is required for operational and transitable bridges within 30 and 5 years, respectively. Being the bridges at hand verified as transitable, the road administrator chose to demolish and rebuild them. Meanwhile, a continuous monitoring system was installed on one bridge (UB) to ensure safe usage, following the Guidelines 2022. The latter will be discussed in the sequel.

**Figure 5.** Results of the static assessment on the deck: (a) typical simply supported span, (b) simply supported span within span 4, (c) Gerber girders

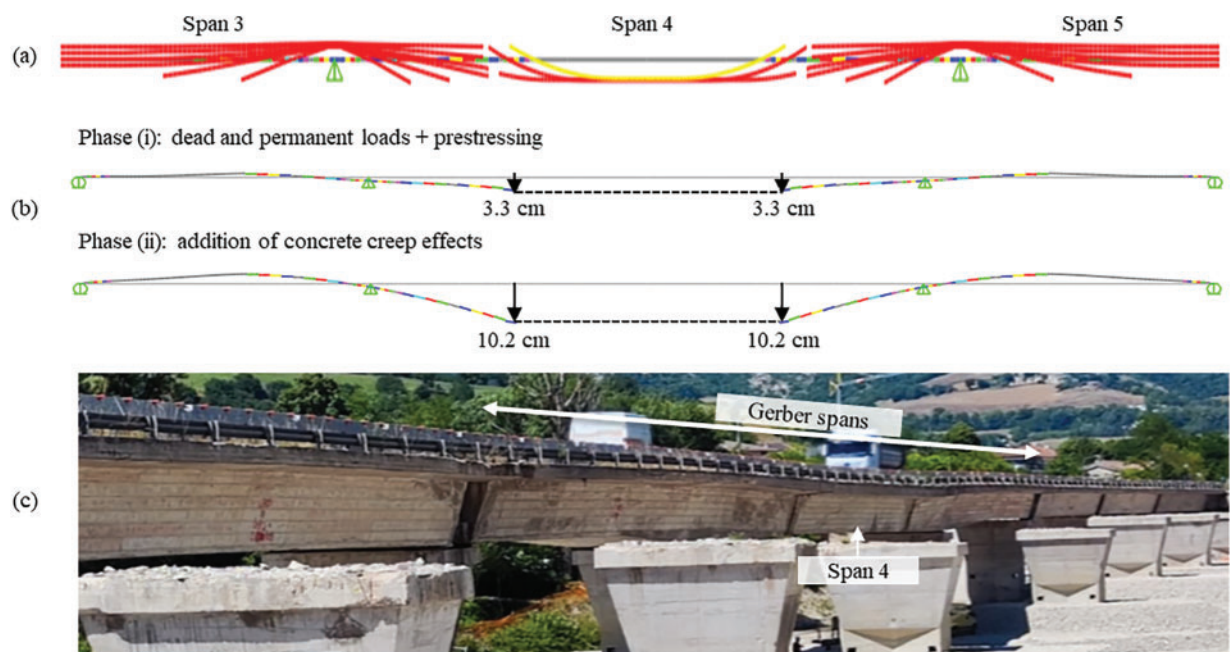
Due to pronounced deflection in span 4 (Gerber scheme), the impact of prestressing on deck deformation is analyzed, trying to correlate the evident lowering to the intrinsic characteristics of the structure and/or to the prestressing system. Starting from the model of spans 3, 4, and 5 (Fig. 4c), prestressing cables are added by using the “Tendon” element command and by considering their actual layout, both planimetrically and altimetrically (Fig. 6a). Prestressing forces acting on cables are estimated starting from the results of the experimental campaign performed to acquire data on the mechanical properties of construction materials. Specifically, de-tensioning tests were performed on 4 wires of different cables, obtaining residual tension values around 630–810 MPa.

**Figure 6.** Numerical investigation of the downward deflection of the Gerber scheme spans: (a) developed FEM, (b) analyses in two different phases, (c) on-site picture of UB after the DB demolition

the suspended deck is drawn undeformed. Indeed, on-site pictures (Fig. 6c) reveal that the simply supported beam of span 4 does not show any evident deflection. In phase (i), the tendons layout and prestressing fail to ensure upward deflection under permanent structural and non-structural loads, causing the deck to lower by a maximum of 3.1 cm at the half-joints. In phase (ii), creep effects are added following the Eurocode 2,<sup>34</sup> which amplifies the initial elastic deformation by a coefficient of 3.3, resulting in a maximum lowering of 10.2 cm. This estimation is conservative as it does not account for the reduction in prestressing due to creep. The numerical displacement profiles (Fig. 6b) match the observed ones during visual inspections (Fig. 6c), indicating that the downward deflection of the deck in the Gerber scheme is primarily caused by the design layout of the prestressing tendons and the cumulative effects of long-term concrete creep instead of damage to the structure.

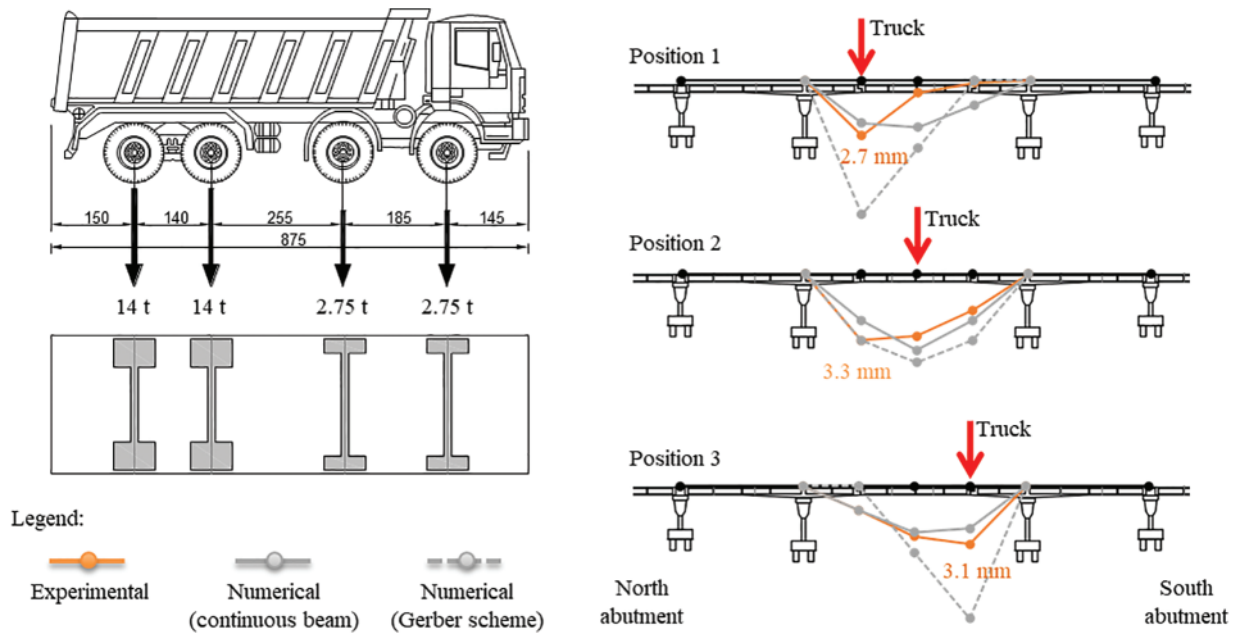
**Figure 9.** Results of the static load tests performed on the main span (Span 4) of DB (dimensions of truck geometry are in cm)

non-symmetric boundary conditions offered by the two half-joints at the edges of the simply supported beam are probably the most responsible for the non-symmetric response of the span during the proof load.

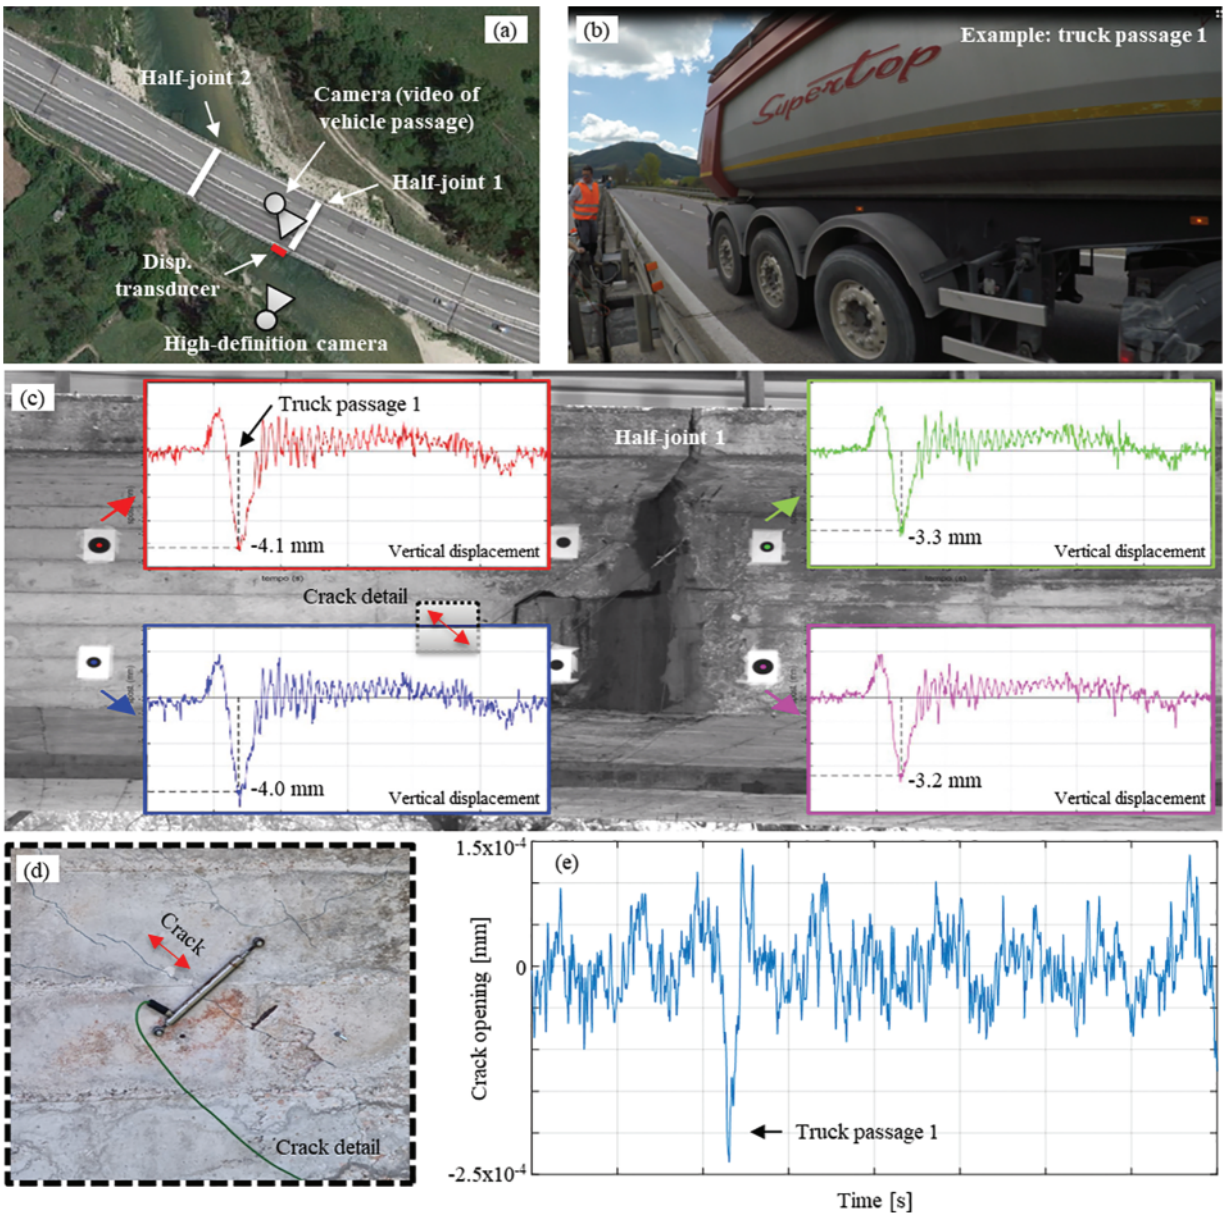
**Figure 12.** Dynamic tests performed in April 2023: (a) measurement setup, (b) example of a heavy truck passage, (c) vertical displacements of targets installed on the lateral side of the deck in correspondence of the half-joint one due to the heavy truck passage, (d) displacement transducer mounted on a diagonal crack close to half-joint one and (e) relevant displacements due to the truck passage

The maximum measured deflection was about 4.1 mm. The vertical displacements observed align with those measured during the static tests conducted in March 2022. However, these static tests do not account for dynamic effects. In the meantime, the opening of the monitored crack was measured as well. Fig. 12d shows the evolution of the crack opening during the test campaign; the peak observed during truck passage 1 was minimal (around  $2.5 \times 10^{-4}$  mm), indicating that the bridge's normal operation, even under heavy loads, did not lead to significant crack openings. This suggests the cracks are unlikely to be caused by regular operating conditions.

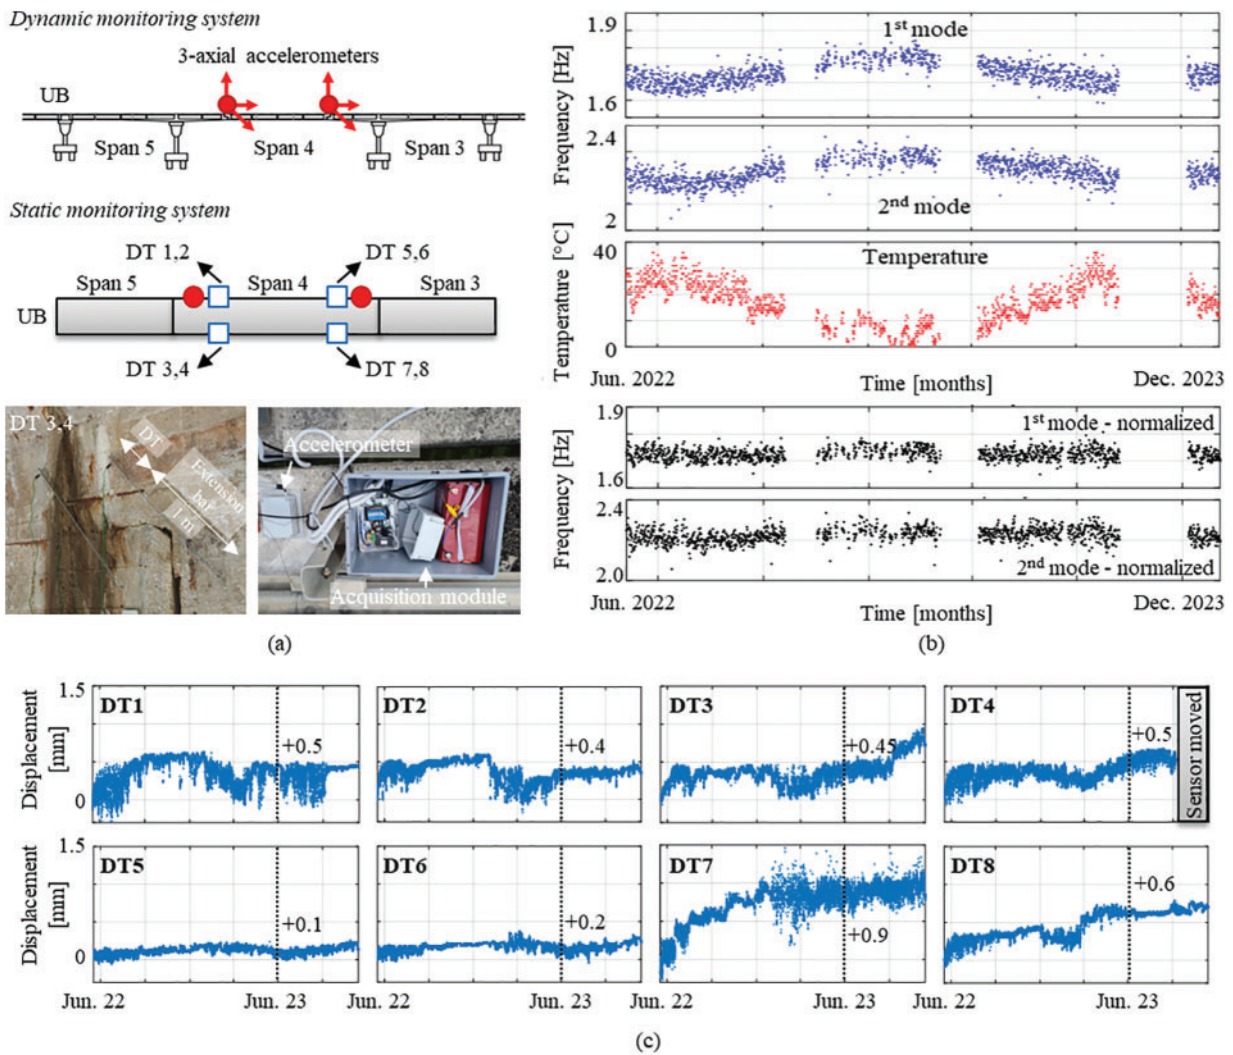
**Figure 14.** Static and dynamic monitoring system: (a) SHM system setup and pictures, (b) dynamic and (c) static monitoring results (+ sign means crack opening/widening)

Results of the static monitoring are reported in Fig. 14c in terms of displacement time histories. For each transducer, the mean value of measurements after 1 year monitoring (Jun 2022–2023) is reported in the graphs. This data is useful to compare the measurements neglecting the environmental effects on the crack opening/closing. All values are positive, meaning a widening of cracks, albeit very low, being the maximum one lower than 1 mm.

In October 2023, the static monitoring system was slightly modified, moving DT 4 across one crack (thus removing the extension bar) considered worthy of being monitored alone (the same crack monitored during the April 2023 test campaign and showed in Fig. 12d). Also in this case, in this short period of monitoring (Oct.–Dec. 2023), DT 4 experienced a very low widening, about 0.1 mm in 3 months.
