Dynamic Investigations before and after the Strengthening of a Masonry Arch Bridge

Paolo Borlenghi and Carmelo Gentile*

Abstract: The bridge crossing the Gesso River is a multi-span masonry arch bridge built in the 19th century in Cuneo, Piedmont, Italy. Due to extended local degradation and damage, the bridge recently underwent a significant strengthening intervention. Ambient vibration tests were performed both before and after the strengthening to assess the effectiveness of the repairs. The paper presents the results of the dynamic investigations, identifying the modal characteristics of the masonry bridge through different techniques. The pre-intervention analysis revealed clear anomalies, including a sort of “frequency splitting” phenomenon and irregularities in the mode shapes that were localized in the regions of maximum masonry decay. After the strengthening works, the identified modal parameters showed an increase in natural frequencies, along with the resolution of previously identified mode shape irregularities, indicating a clear improvement in the bridge’s structural condition.

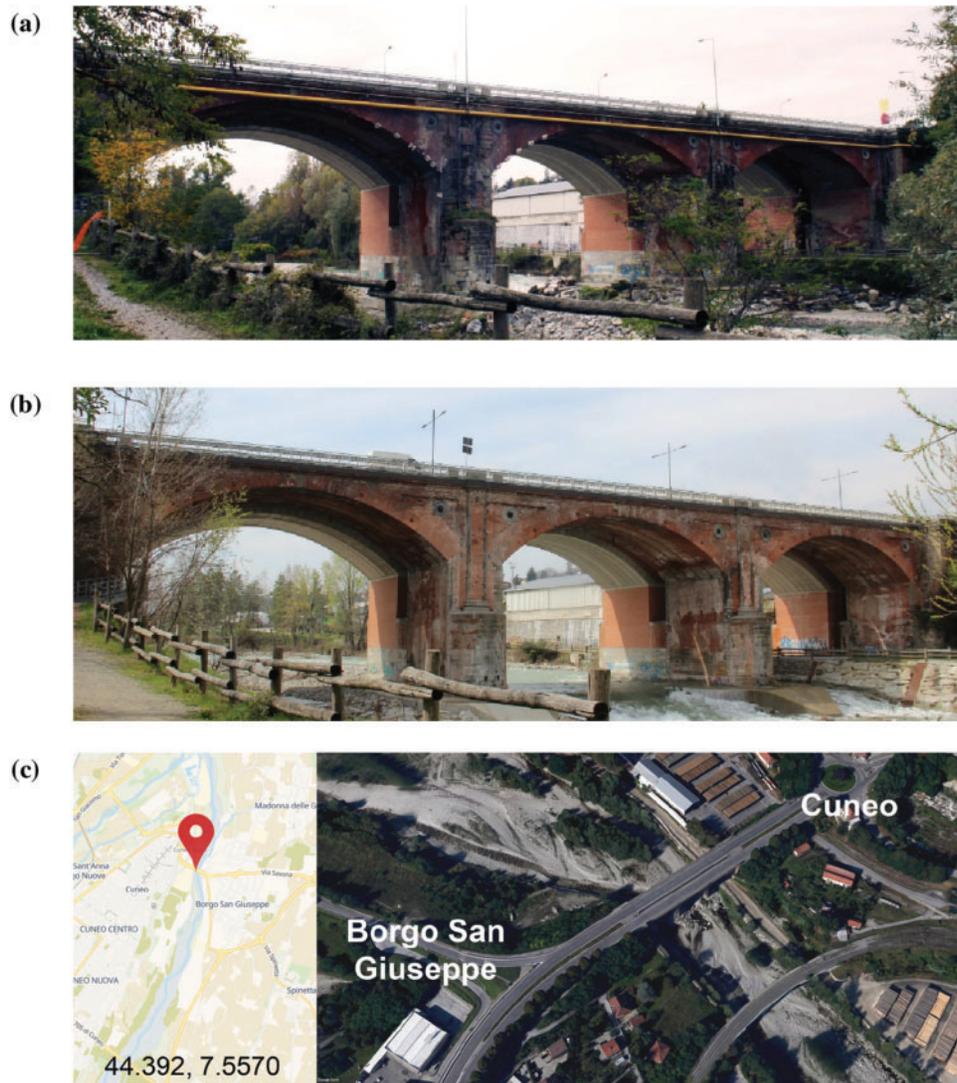
Figure 1. Views from the downstream of the bridge over the Gesso River (Cuneo, Italy) before (a) and after (b) the repair interventions, and (c) bridge location

As shown in the geometrical representations in Fig. 2, the bridge under study is approximately 115 m long (including abutments), with a single carriageway 7.30 m wide and two lanes. It consists of three arches with spans of 24 m and two piers placed in the riverbed. The pier height from the foundation level is approximately 10.60 m, and their width along the longitudinal direction is 4.80 m. The piers of the two bridges are connected to each other for the first 6.40 m above the foundation level, while the remaining upper structures are completely independent (this detail is visible in the pictures in Fig. 1).

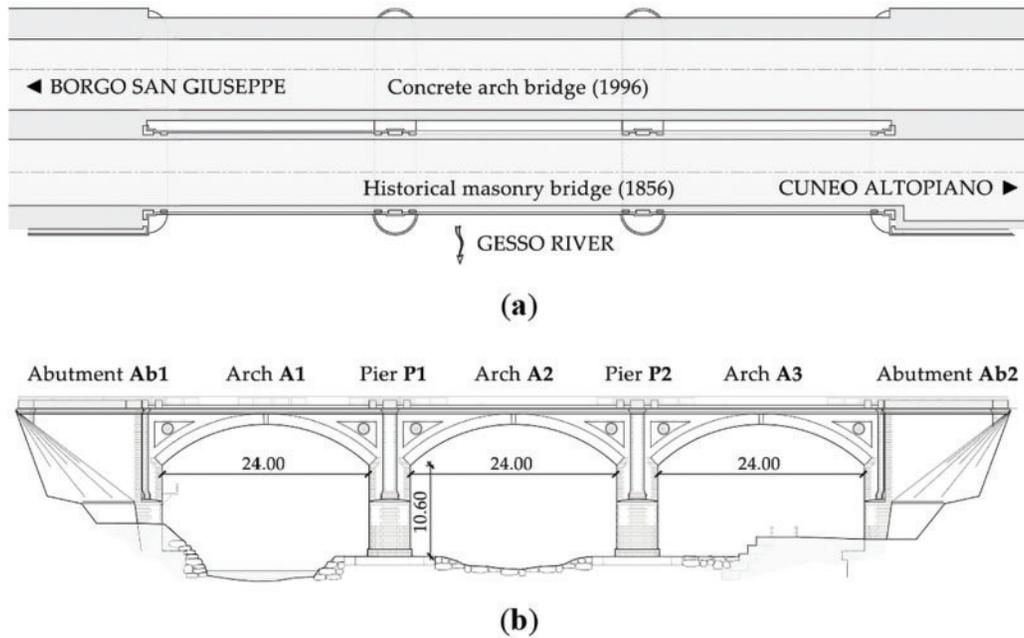
Figure 2. Geometry of the bridge over the Gesso River (Cuneo, Italy): (a) plan and (b) downstream elevation (dimensions in m)

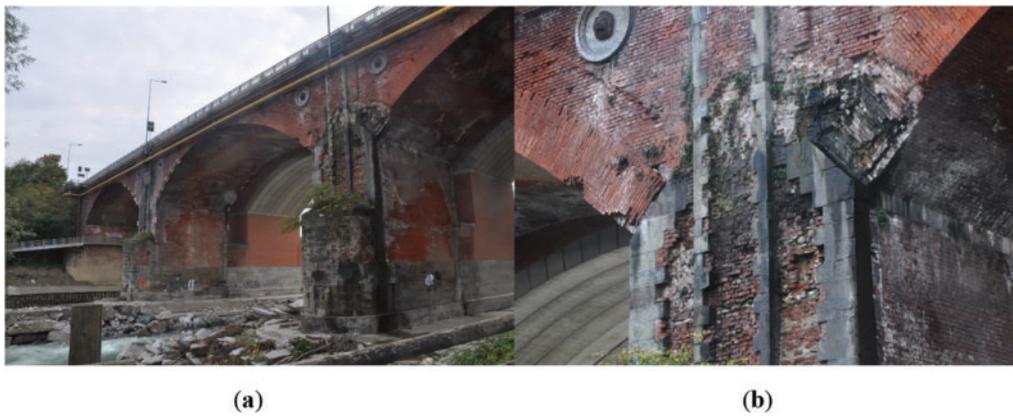
Figure 3. Damages observed at the top of pier P2: (a) general view from downstream and (b) detail of the decayed masonry of the arch A3 skewback (on the right)

In preparation for the dynamic tests, visual inspections were performed (Fig. 3). The arch barrels were generally characterized by superficial damage affecting durability, such as black crust, the presence of vegetation, different surface weathering, and diffuse efflorescence. In addition, a severe deterioration of the masonry was localized at the skewback of arch A3 on the side of pier P2 (Fig. 3b).

inspection, the arch barrels are affected in those regions by a severe state of degradation, providing a possible explanation for the identified irregularities.

- Mode L3* exhibits the same mode shape as mode L3 with a slight difference in natural frequency. This phenomenon should be classified as a “frequency splitting”⁴⁸ and, in this case, it is likely related to existing damage at the arch barrels, although this remains an assumption supported by indirect evidence. Particularly, the visual inspections highlighted the presence of discontinuities at the skewback between arch A3 and pier P2, where mode L3 exhibits the maximum modal displacement.

The visual inspections carried out in 2019 revealed the general state of degradation of the brick masonry and the presence of a severe discontinuity at the skewback between arch A3 and pier P2. The OMA highlighted irregularities in the mode shapes, which were more evident around the structural discontinuity. In addition, the presence of two vibration modes characterized by a slight difference in natural frequencies but the same mode shape (i.e., L3 and L3*) suggests the presence of a “frequency splitting” phenomenon caused—again—by the discontinuity at pier P2—arch A3.

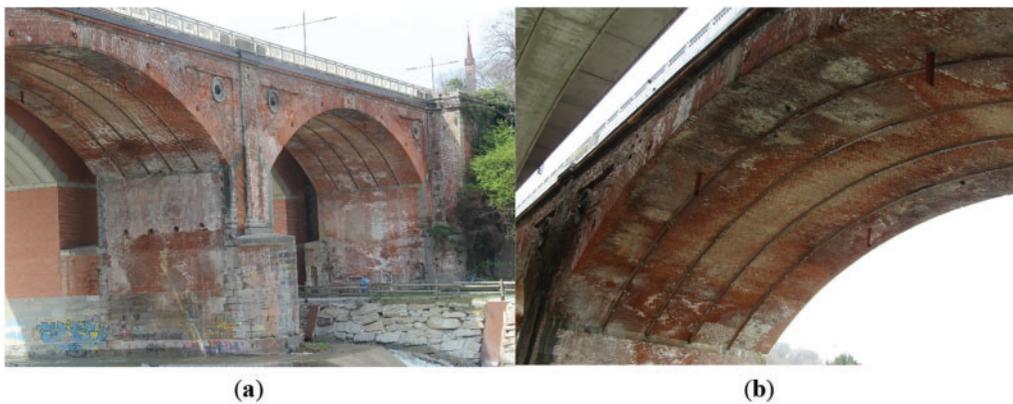
Figure 4. Strengthening works: (a) view from downstream of arches A2–A3 and pier P2 and (b) the four steel strips and the transverse connections of the external arch

The strengthening of the bridge (Fig. 4) included the installation of four steel strips at the intrados of each arch barrel, together with the reconstruction of missing masonry portions. Specifically, the local dismantling and reconstruction (often called “scuci-cuci”) was applied to fill gaps and restore continuity among damaged masonry portions. In addition, transverse bars were added to connect the external arches with the rest of the arch barrels, ensuring the monolithic behavior of the vaults. Finally, material restoration was carried out using traditional methods, involving cleaning by hydro-washing to remove traces of limestone on the bricks, biocidal treatment to eliminate vegetation, moss, and lichen from masonry surfaces, and protective treatment of decorative stone elements in the form of carved lion heads.

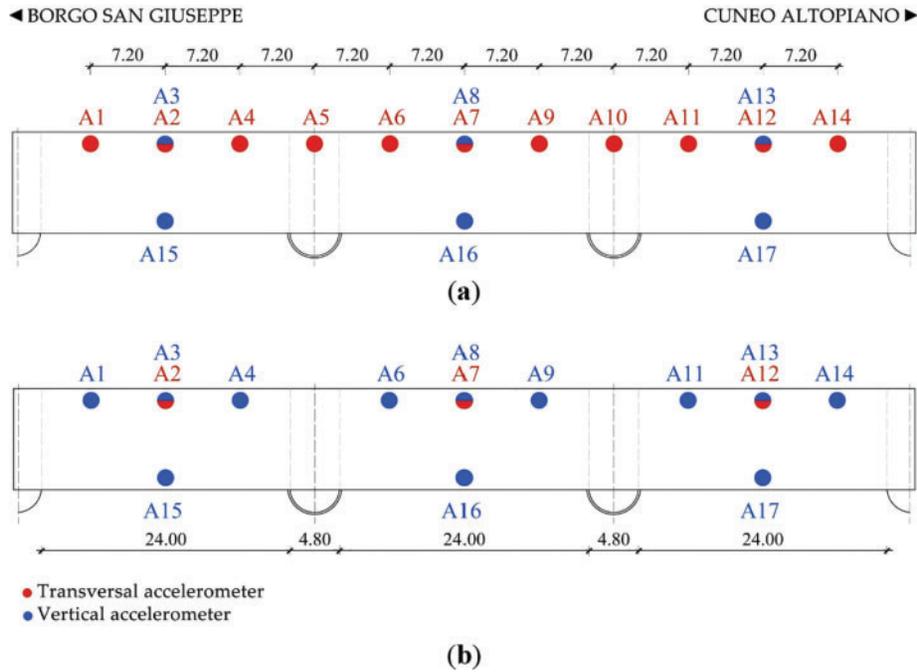
Figure 5. Sensor's layout adopted during the dynamic tests: different configurations to characterize both the transversal (a) and vertical (b) responses

The experimental procedures adopted for the two tests included the measurement of the horizontal and vertical responses of the bridge under operational conditions: due to the presence of sidewalks on both sides, neither traffic interruption nor traffic restrictions were required. Overall, the bridge was instrumented with 17 highly sensitive piezoelectric accelerometers, according to the two measuring setups shown in Fig. 5. The first setup was mainly aimed at characterizing the horizontal response of the structure, with 11 transversal and 6 vertical accelerometers. The second setup was devoted to describing the vertical vibration modes with a higher accuracy, involving 12 vertical and 3 transversal accelerometers. During both setups, 6 vertical (A3, A8, A13, and A15–A17 in Fig. 5) and 3 transversal (A2, A7, and A12 in Fig. 5) accelerometers were used as reference transducers.

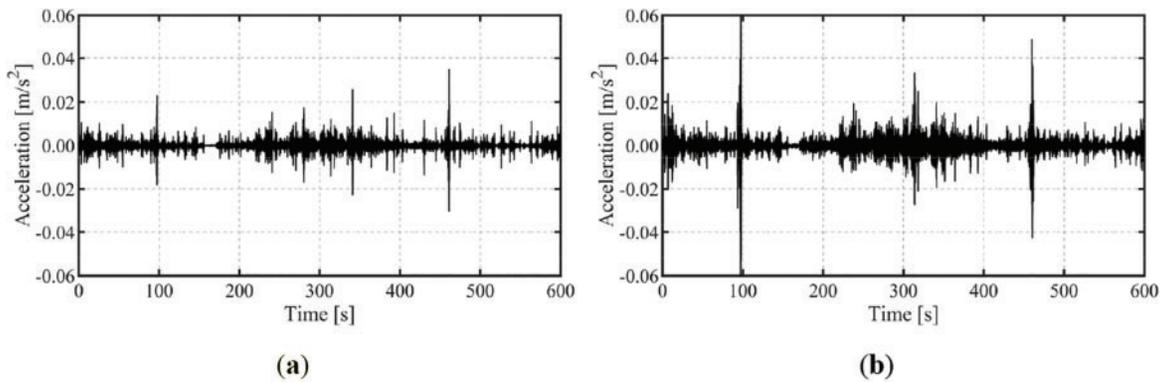
Figure 6. Typical acceleration time series recorded at the center of arch A3 (sensors A12 and A13) in October 2019: (a) lateral and (b) vertical responses

windows of 5400 s. Fig. 6 presents a sample of acceleration time series collected in October 2019, highlighting that the level of vertical vibration is about two times higher (both in terms of RMS and peak accelerations) than that observed in the lateral direction.

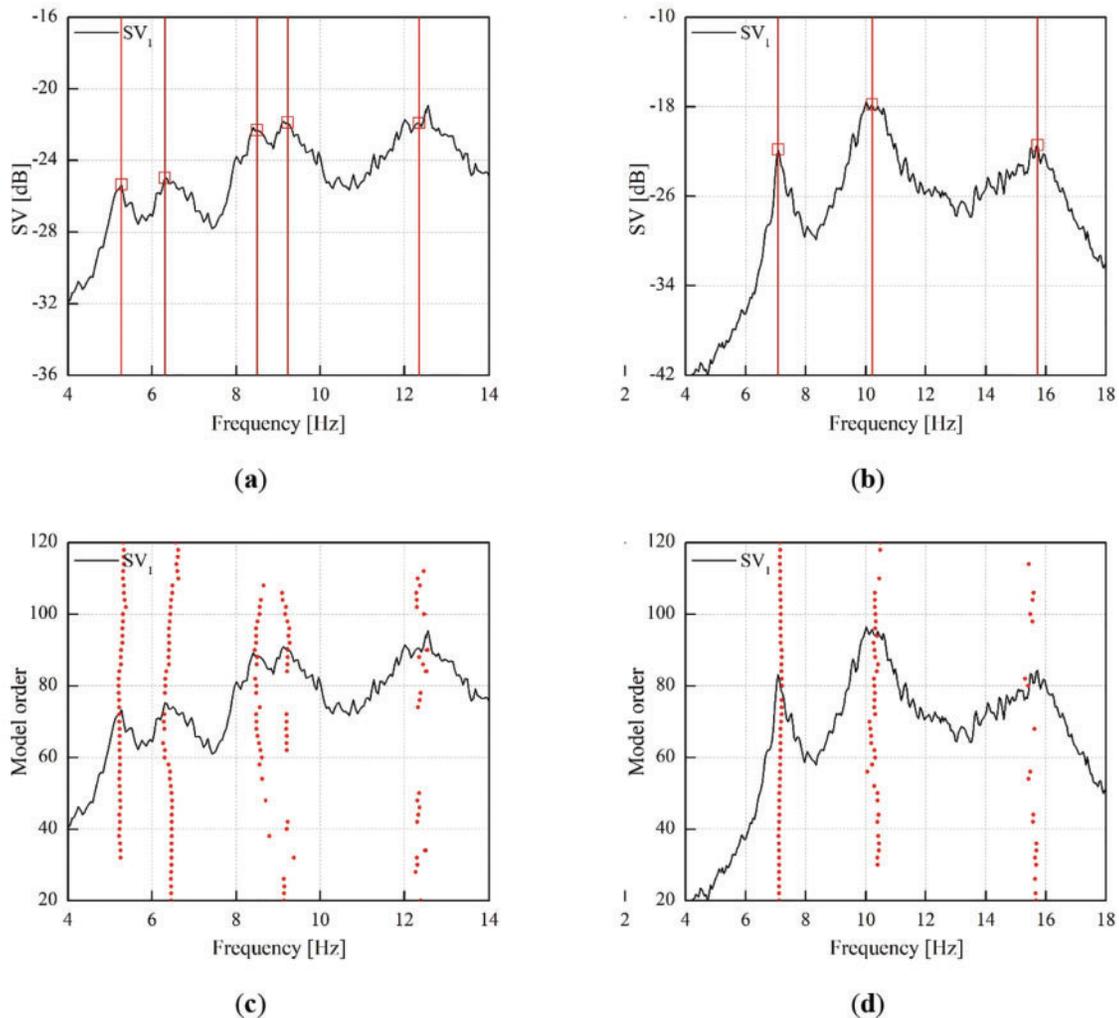
Figure 7. Identification of vibration modes from the AVT of October 2019: (a, b) first singular value (SV) curve and peak picking (FDD) of horizontal and vertical accelerations, respectively; (c, d) stabilization diagram (SSI-Cov) of horizontal and vertical accelerations, respectively

As shown in Fig. 7, the vibration modes are identified from the local maxima of the first SV line using the FDD method (Fig. 7a refers to lateral responses, whereas Fig. 7b relates to the vertical ones) and through the alignment of stable poles in the stabilization diagram obtained by applying the SSI method (Fig. 7c refers to lateral responses and Fig. 7d to vertical ones). As expected, the spectral analysis of vertical accelerations exhibits more evident peaks due to the higher excitation level. Nevertheless, both methods provided consistent indications of the same vibration modes in both lateral and vertical responses.

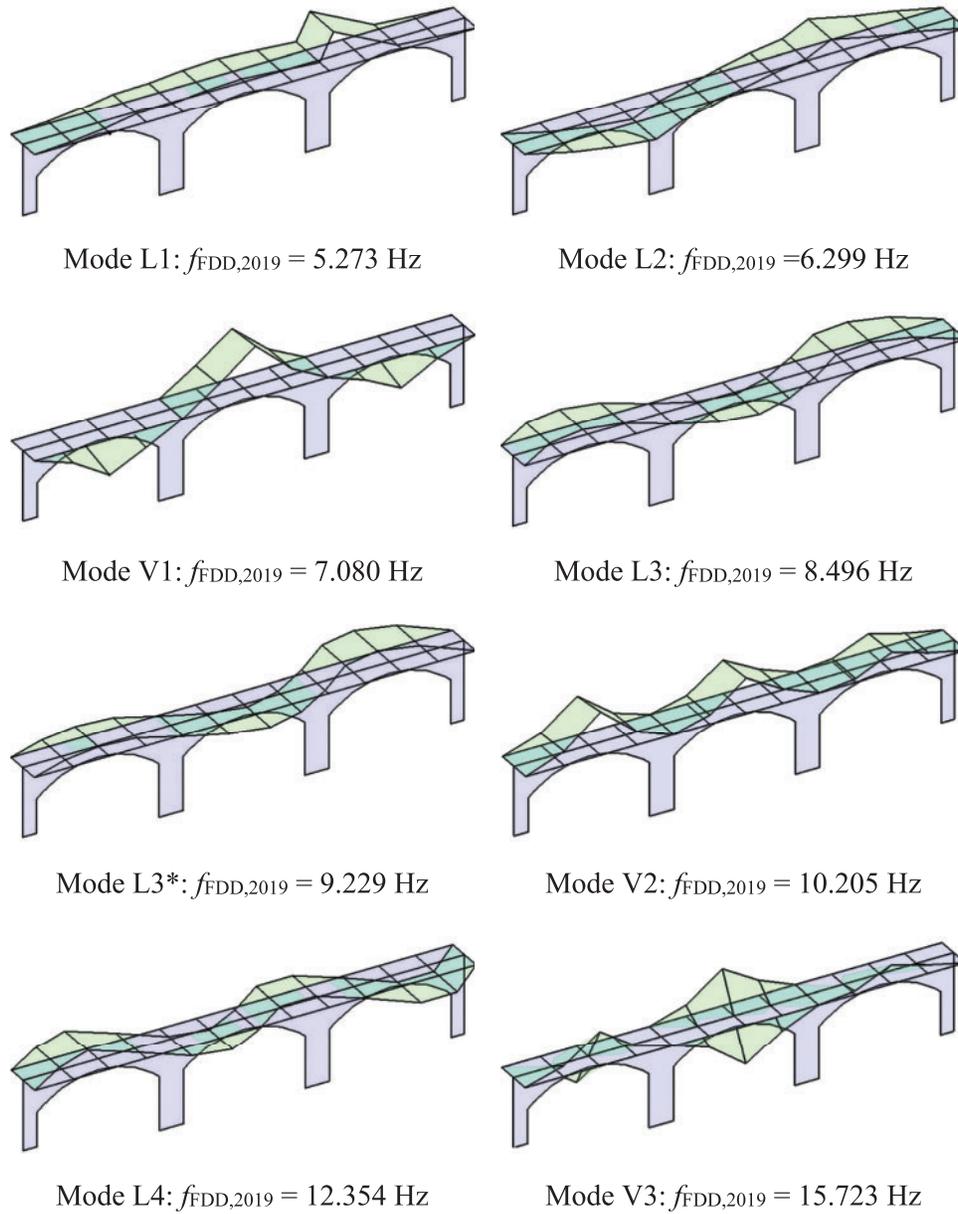
Figure 8. Vibration modes identified before the repair intervention in October 2019 (L = dominant lateral, V = dominant vertical)

Fig. 8 shows the mode shapes identified using the FDD method. The fundamental vibration mode is in the transverse direction, and with a frequency of 5.3 Hz. The lateral modes exhibit an increasing number of half-sine waves and inflection points, with the only exception being mode L3*, which has the same mode shape as mode L3. The mode shapes V1 and V2 are associated with vertical bending, while V3 corresponds to a torsional mode.

- The damping estimates are generally relatively high, with modes L1, L2, and L4 having values higher than 7%.
- Modes L1 and L2 exhibit a local distortion of the mode shapes, localized at the third quarter of arch A1 (Borgo side) and—more evidently—at the first quarter of arch A3 (Cuneo side). As highlighted by visual

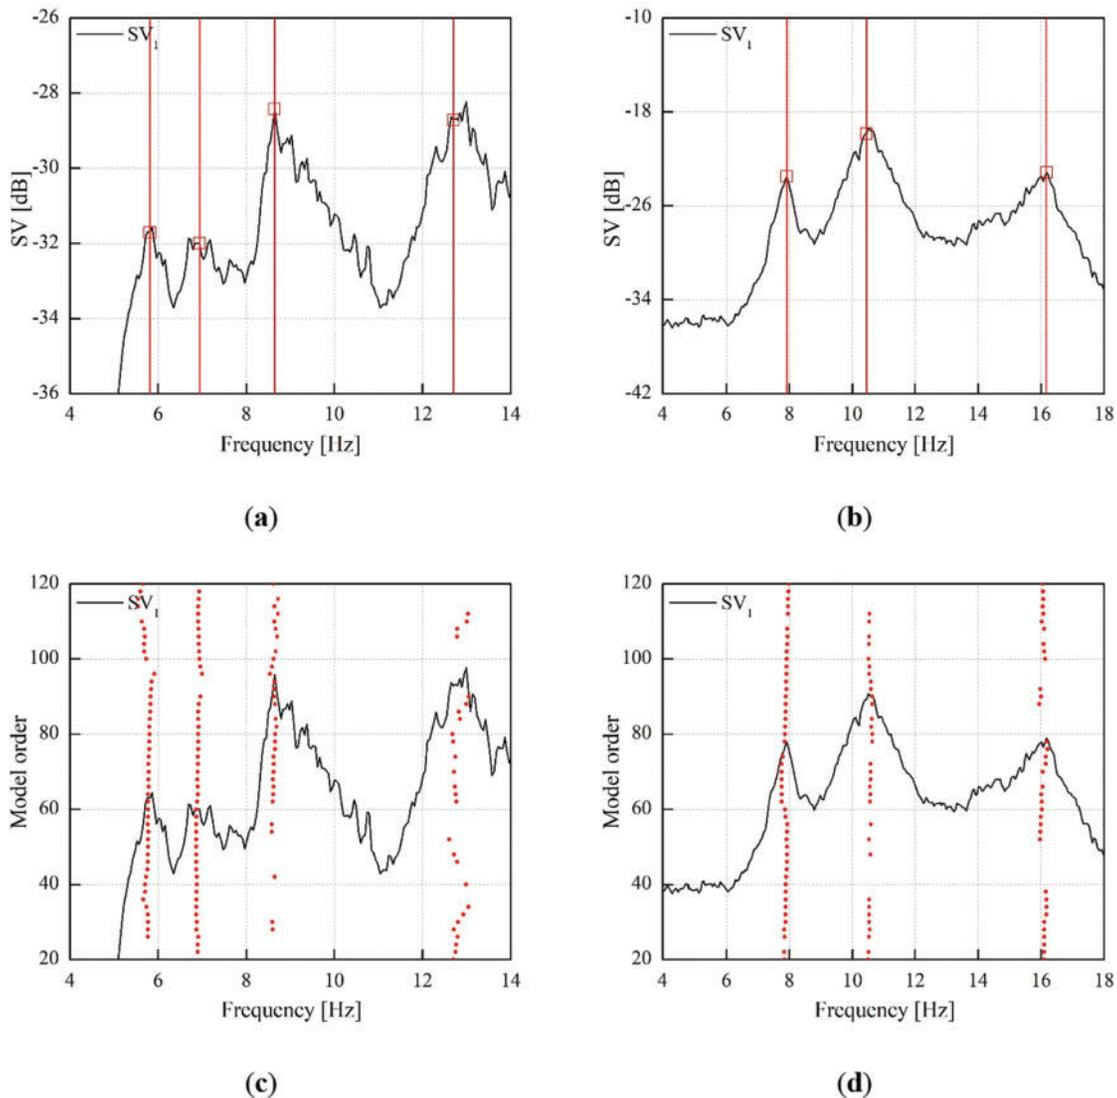
Figure 9. Identification of vibration modes from the AVT of March 2024: (a, b) first singular value curve and peak picking (FDD) of horizontal and vertical accelerations, respectively; (c, d) stabilization diagram (SSI-Cov) of horizontal and vertical accelerations, respectively

The output-only identification was first performed with the FDD technique: Figs. 9a, 9b shows the first SV line obtained from the analysis of the lateral and vertical accelerations, respectively. As shown by the alignments of stable poles in Figs. 9c, 9d, the SSI-Cov algorithm was also applied to lateral and vertical responses, respectively. It should be noted that the presence of normal modes is clearly highlighted by both the local maxima of the SV lines (FDD) and the corresponding alignments of stable poles (SSI-Cov).

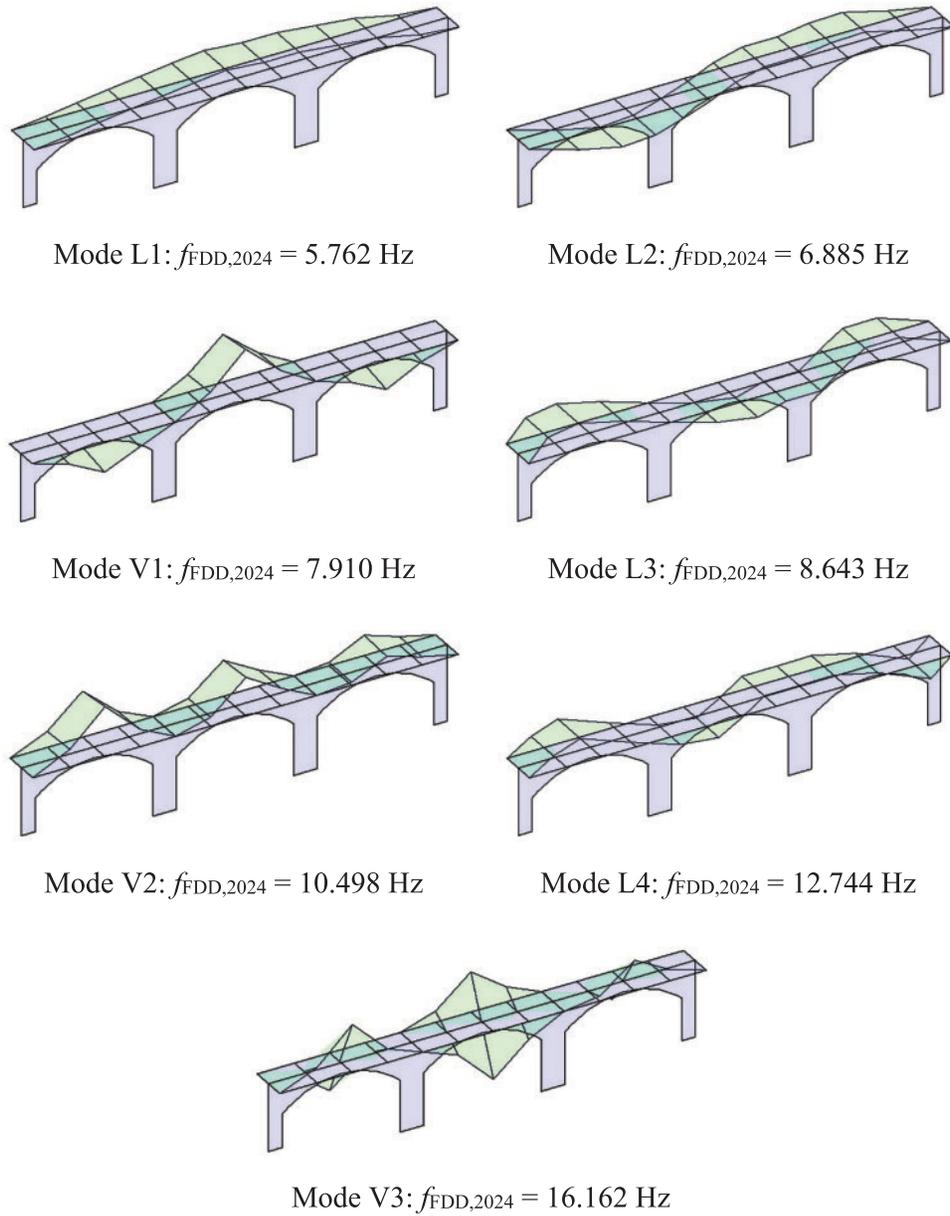
Figure 10. Vibration modes identified after the repair intervention in March 2024 (L = dominant lateral, V = dominant vertical)

Fig. 10 illustrates the mode shapes identified by applying the FDD method. The fundamental vibration mode is characterized by a predominant transverse modal displacement with a natural frequency of 5.8 Hz. The subsequent lateral modes exhibit an increasing number of half-sine waves and inflection points, as expected. Furthermore, vibration modes V1 and V2 are associated with vertical bending, while mode V3 represents a vertical torsion mode.

- The estimates of modal damping are particularly high for modes L1 and L2, with values greater than 9%, while for the other modes, the damping ranges from a minimum of 3% for mode V3 to a maximum of 5.6% for mode L4.
- The mode shapes are generally regular but not perfectly symmetrical with respect to the center of the structure. This is particularly visible in the mode shapes L2 and L4, in which the modal displacements at piers P1 and P2 are nonsymmetric.

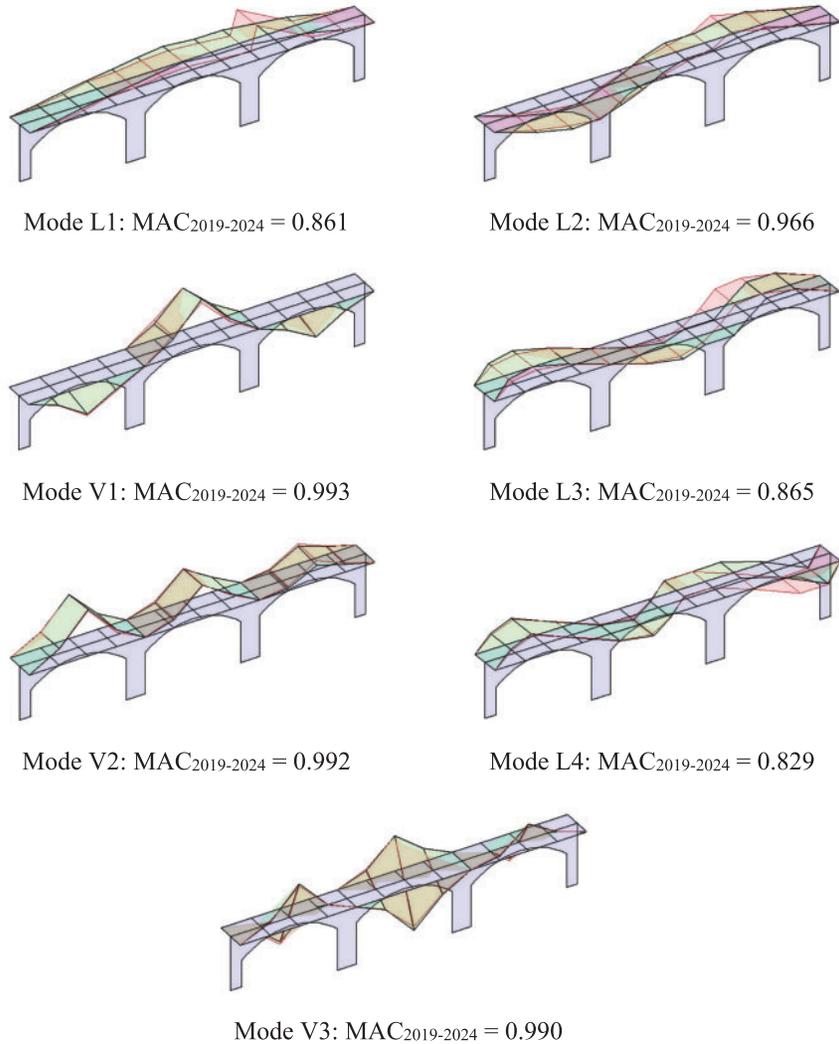
**Figure 11.** Comparison between the vibration modes identified in 2019 and 2024

Table 3 and Fig. 11 illustrate the comparison between the current dynamic characteristics (2024) and those identified in 2019 using the FDD method. In particular, Table 3 shows a substantial increase in natural frequencies, with an average percentage value across the seven modes of +5.4%, and a

Fig. 11 presents a comparison of the mode shapes with the associated MAC factor. The consistently high MAC correlation factors confirm that the nature of the modes identified in the two tests is the same, with values exceeding 0.8. However, the comparison reveals localized differences in the modal deformations before and after the intervention. In the 2019 test, irregularities were found in the modal deformations at measurement points A4 (third quarter of the lateral arch on the Borgo S. Giuseppe side) and, more prominently, A11 (first quarter of the lateral arch on the Cuneo Alpiano side). In the 2024 investigations, the previously observed distortions appear to have been effectively resolved, suggesting a clear improvement in the bridge's condition.
