# Timber Bridge Pile Splicing with Traditional and Fiber-Reinforced Polymer Wrap Methods

**Author keywords:** Timber Piles; traditional splicing mechanisms; glass fiber-reinforced polymer composite wraps

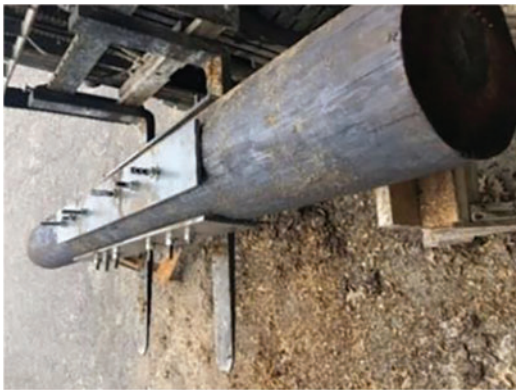
**Figure 2.** Steel plate splice specimen

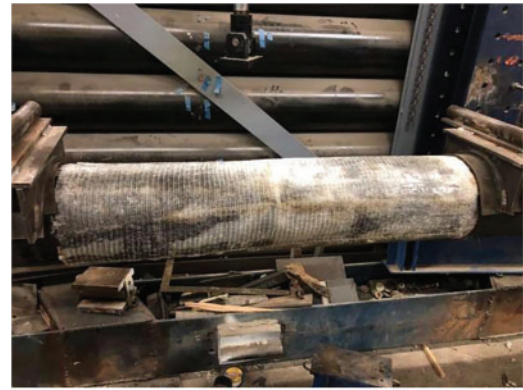
**Figure 4.** Finished pile with glass fiber-reinforced polymer composite splice

splice (Fig. 4) mechanism were constructed and tested under various loading conditions. The three traditional splicing mechanisms tested in this program were flat steel plate, steel C-channel, and wooden plate. Each of the four splice designs was tested under shear, four-point bending, and axial compression to establish their load capacities. Test data were analyzed to determine the axial, bending, and shear stiffnesses and strengths of each splice design. The FRP wrap splice mechanism was further analyzed to develop the strength capacity equations.

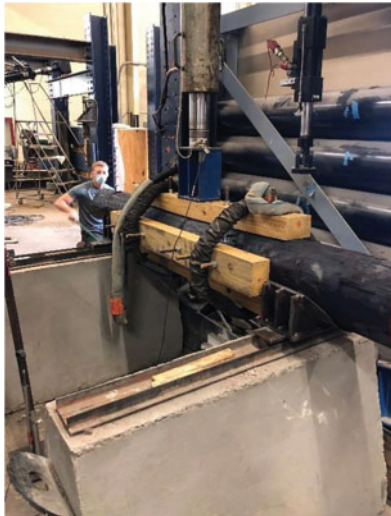
**Figure 3.** Shear test setup with wooden splice

An 8 ft (2.44 m) long pile was placed on steel saddles following the splicing at the center of the span of the refurbished pile (Fig. 3). The refurbished timber pile was loaded at the center using hydraulic actuator, with a load cell measuring the amount of force applied transversely onto the pile. Deflections were measured using linear variable differential transformer (LVDT) while applying the load.

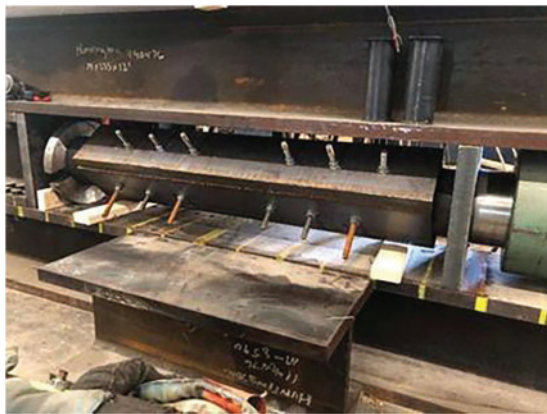
**Figure 9.** Axial test setup with C-channel splice

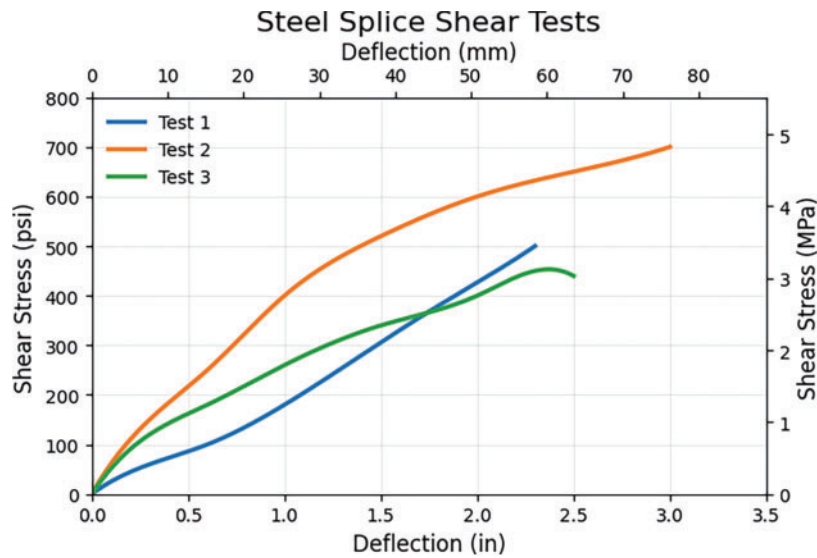
Figure 10. Shear stress versus deflection for steel plate splice

Shear stress versus transverse deflection for timber piles spliced with flat steel plates is shown in Fig. 10. The test data revealed a 40% variation in shear stress (500 psi (3.45 MPa) versus 700 psi (4.83 MPa)), which is attributed to the quality of timber pile specimens, and such variation (~40%) is not unusual for large-diameter timbers. Random cracking was observed visually in timber piles and can be attributed to internal flaws in large-size timbers. It was observed that the first test exceeded the deflection measurement limit of the LVDT; hence, it was unable to record ultimate deflection.

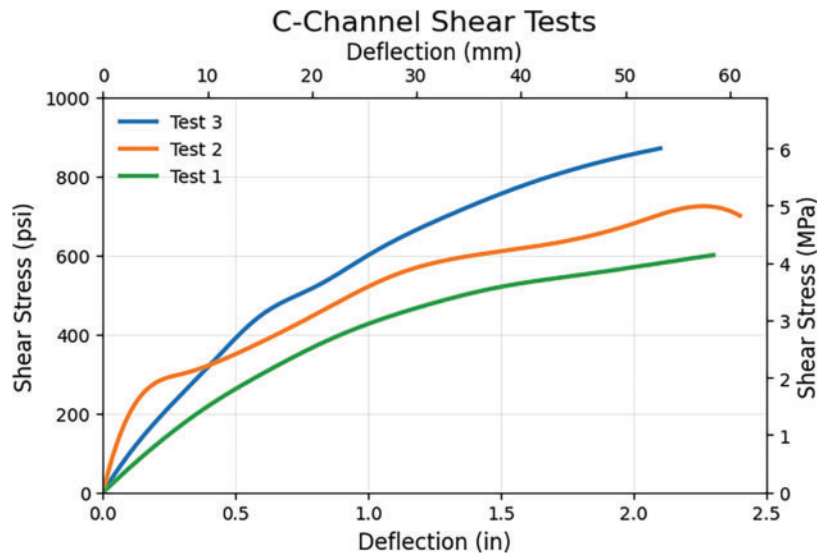
Figure 11. Shear stress versus deflection for C-channel splice

Shear stress versus deflection for timber piles spliced with steel C-channel splicing is provided in Fig. 11. The test data revealed that the shear failure mode is nearly identical in all piles that were tested under shear failure mode. The C-channel method of splicing is found to be stronger than the steel plate splicing method. This is to be expected as the C-channel method provides higher shear resistance than the steel plate splice. Similar to the shear deflection response using steel plate, deflection peaked above the constraints of the test device (LVDT) for test one of this method. The initial slope change in Tests 1 and 2 of the steel plate splicing mechanism may be attributed to the initial internal adjustment of the test specimen at the early stages of loading. The C-channel splicing dug into the wooden pile upon initial loading. The load–deflection slope changes may also be a result of the yielding of steel at the load location, which was observed in multiple specimens that were repaired using this technique.

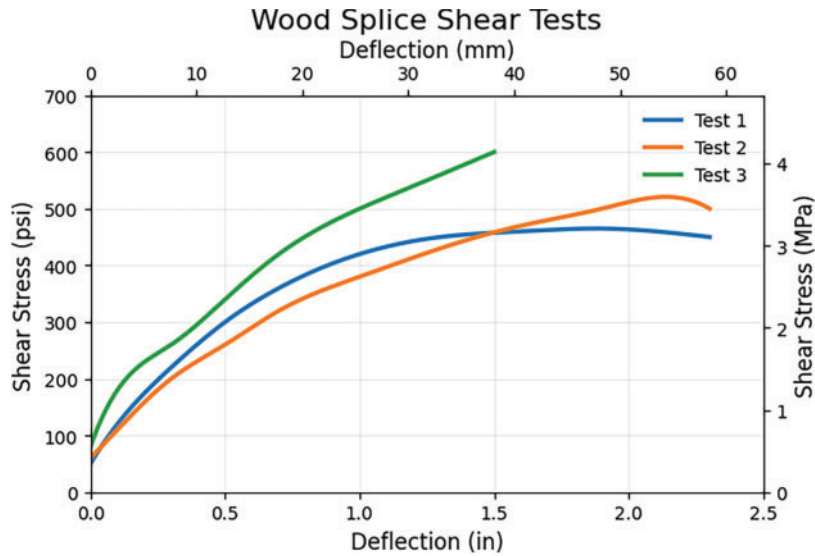
**Figure 12.** Shear stress versus deflection for wood splice

Fig. 12 provides the shear stress versus deflection plots for specimens with wooden plate splicing. The wooden plate splice, however, does not have the same yielding effect as the other two splicing methods. The wood splicing that was tested here was slightly weaker in shear than the other two.

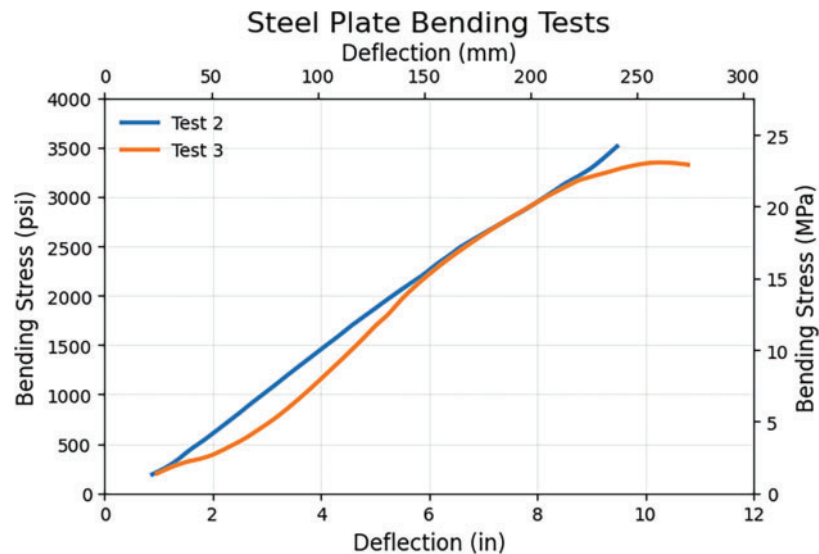
**Figure 13.** Bending stress versus deflection for steel plate splice

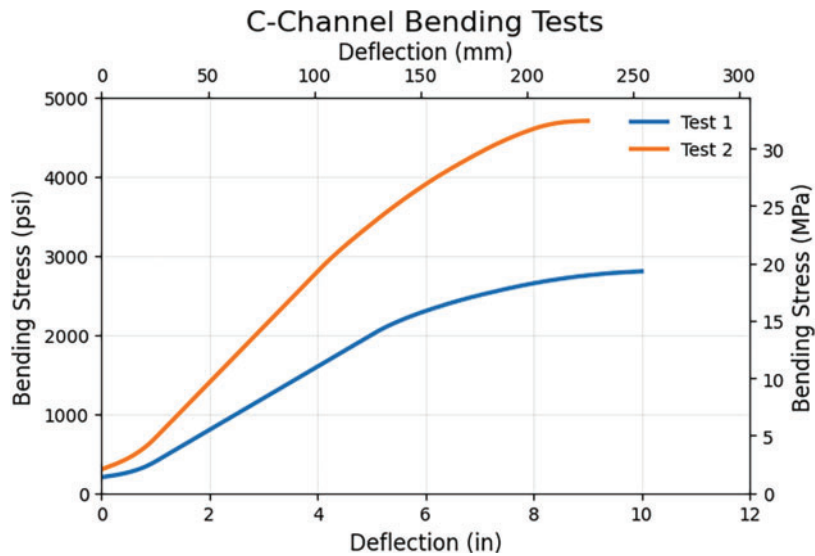
**Figure 14.** Bending stress versus deflection for C-channel splice

For timber piles spliced with the C-channel, three specimens were tested. The bending stress versus deflection data for the third test specimen could not be retrieved; hence, it was not included in Table 3 and Fig. 14. The large deviation in data of the two test samples (Fig. 14) was attributed to the original strength of the timber pile (before splicing) even though the failure behavior of the second test specimen was similar to that of the first one.

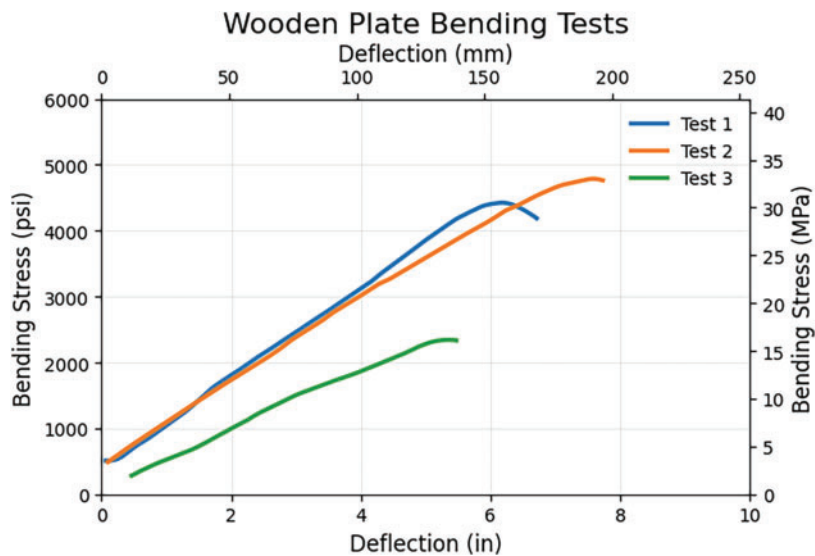
**Figure 15.** Bending stress versus deflection for wood splicing

Fig. 15 reveals the bending versus deflection response of specimens spliced with wood. No significant change in bending versus deflection to failure was noted. It reveals that the splicing system causes the pile to split at failure, and not yield as observed in steel-plate or C-channel splicing.

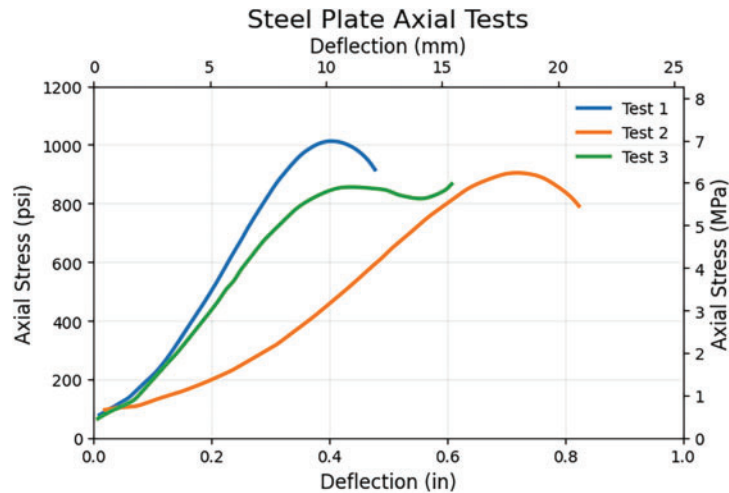
**Figure 16.** Axial stress versus deflection for flat steel plate splice

Fig. 16 shows the axial stress versus deflection relationship for specimens with flat steel plate splicing. Piles did not have perfectly flush cuts at the ends where they were in contact with steel plates at each end of the pile. There was an initial loading period of each test when the pile settled into the stiff steel plates that were exerting axial stress at the ends of the cut section of timber piles. Due to this initial settling period, initial axial deflection was nonlinear with applied load by a small amount and was evident in Fig. 17.

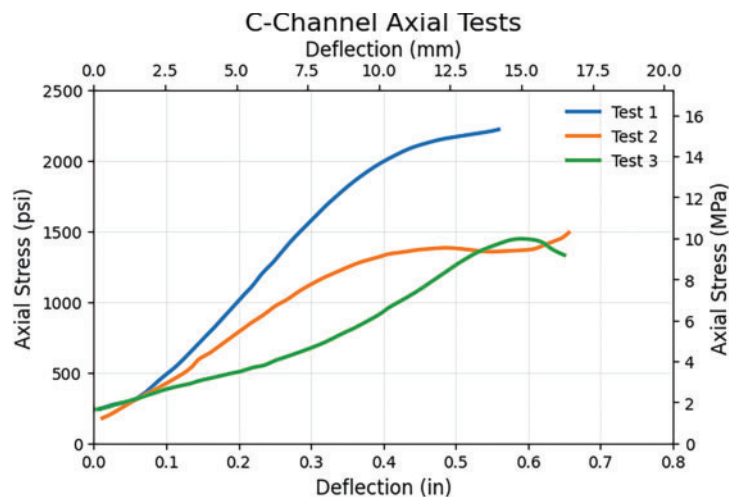
**Figure 17.** Axial stress versus deflection for C-channel splice

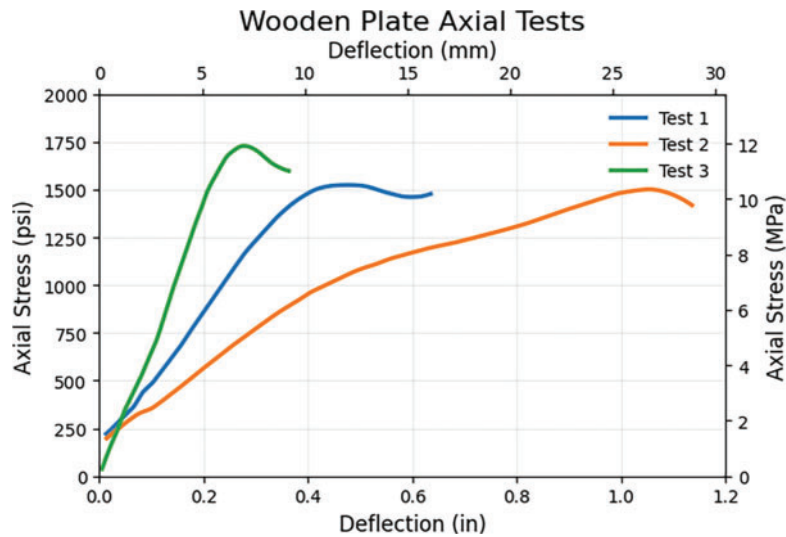
Figure 18. Axial stress versus deflection for wood splice

Fig. 18 provides the axial stress versus deflection relationship for piles spliced with wood plates. Two of the three test specimens provided large deformations at failure. This was attributed to possible “looseness” of the splicing mechanism with the pile, along with a gap separating the portions of the pile at the splice location.

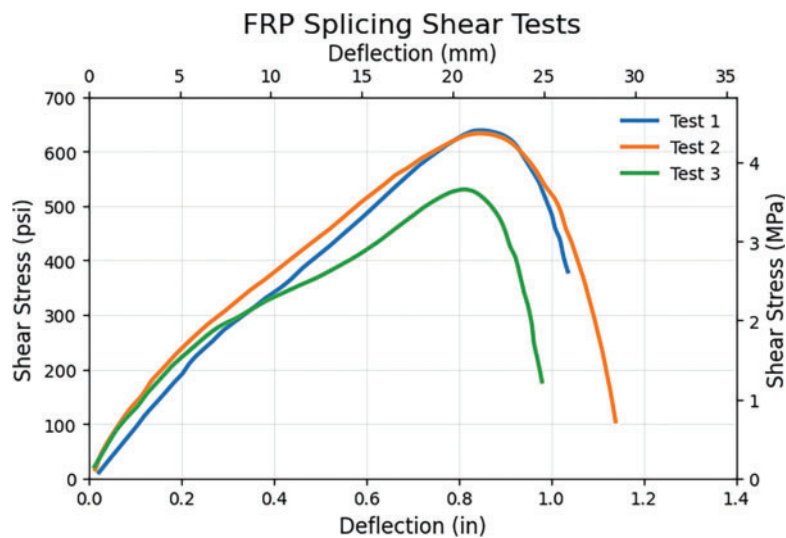
Figure 19. Shear stress versus deflection with FRP splice. FRP, fiber-reinforced polymer

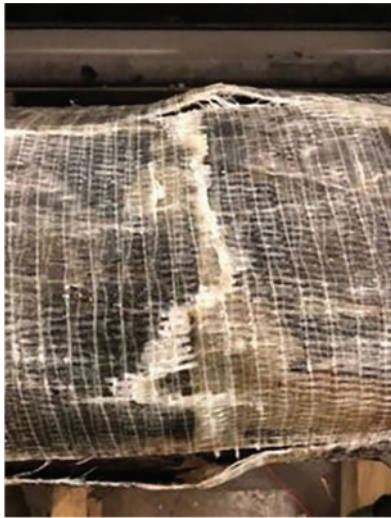
**Figure 20.** FRP splice cracking under applied load at top

FRP splicing ruptures longitudinally near the neutral axis of the pile with the FRP wrap splitting between fibers (Fig. 20), because maximum shear stress is induced under bending at the mid-depth of the test specimens. Furthermore, the failure mode revealed the hoop direction fabric failure,

where hoop fiber was minimal. Therefore, shear resistance of FRP-spliced piles can be improved by modifying the fiber architecture. During loading and unloading stages, buckling related deformation was observed in the splice as shown in Fig. 20.

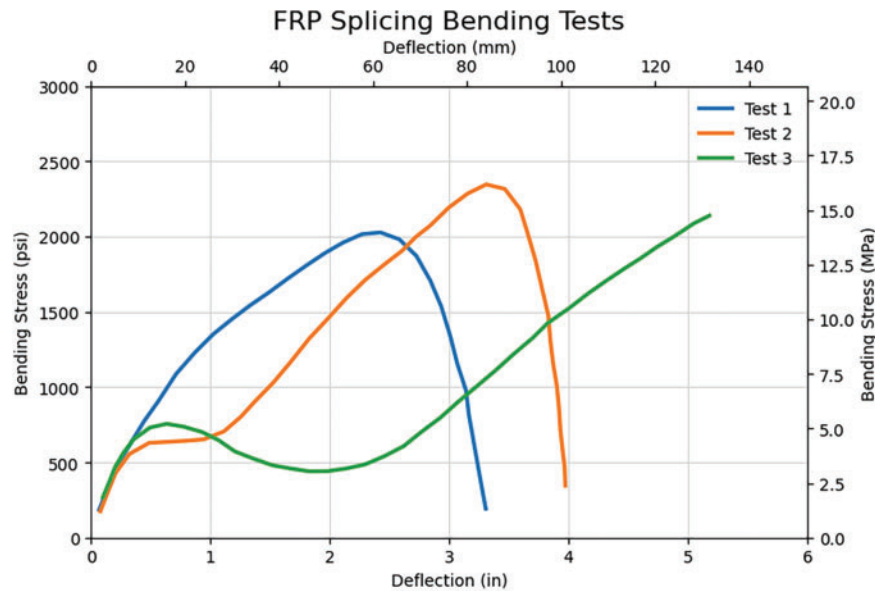
**Figure 21.** Bending stress versus deflection with FRP splice. FRP, fiber-reinforced polymer

The bending test data were analyzed for maximum bending stress versus deflection as given in Table 6. Fig. 21

provides the bending stress versus deflection plots for piles spliced with FRP wraps, revealing lower deflection as well as maximum stress than the traditional methods of splicing. This indicates that not enough reinforcement was provided through the FRP wrap for adequate resistance to bending stress. The “dips” in Tests 2 and 3 in the bending stress versus deflection plots (Fig. 21) are an indication of local buckling and/or debonding of wrap under low bending induced stresses, which is elaborated below.

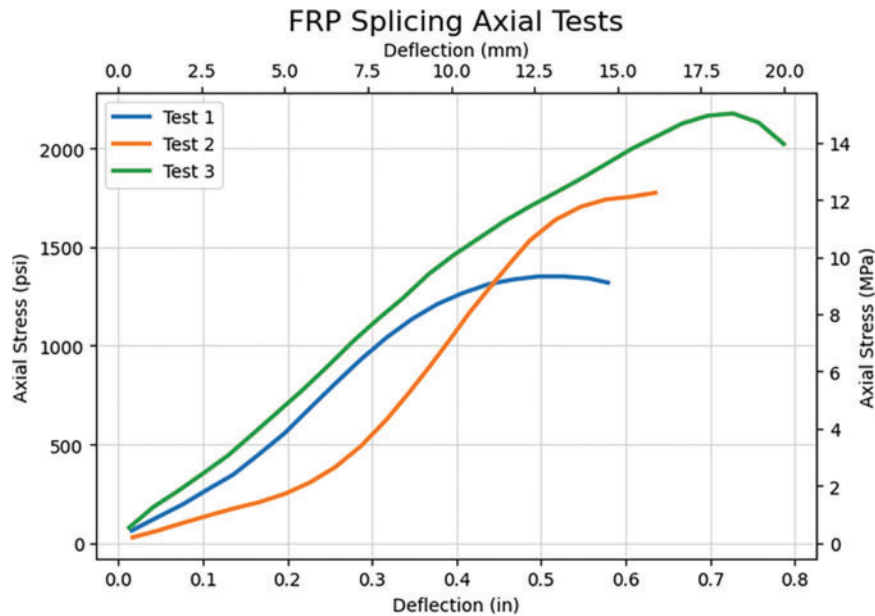
**Figure 24.** Axial stress versus deflection for FRP splice. FRP, fiber-reinforced polymer

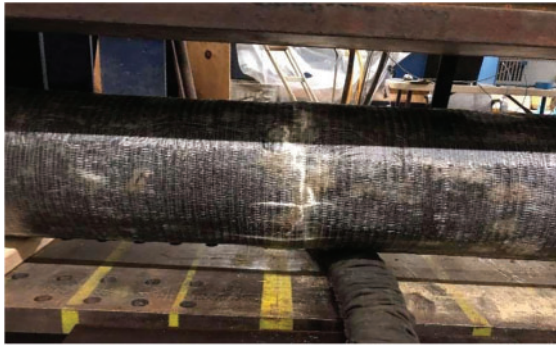
**Figure 25.** Bulging in FRP splice under compression. FRP, fiber-reinforced polymer

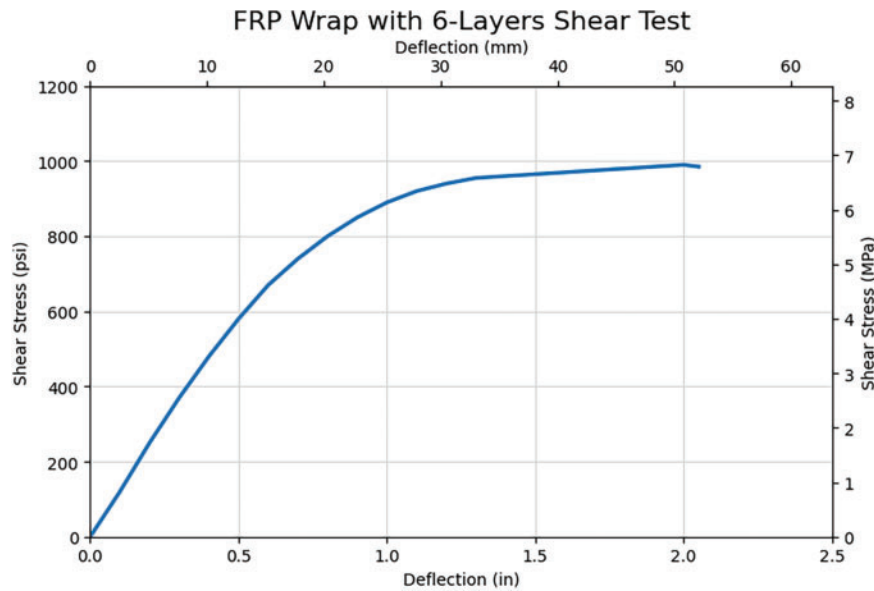
**Figure 26.** Six-layer FRP shear stress versus deflection. FRP, fiber-reinforced polymer

The shear stress versus deflection from the six-layer shear test is shown in Fig. 26, and maximum values are found to be 987 psi (6.81 MPa) and 2.0 in. (50.8 mm), respectively. This splice performed better than the three traditional splicing methods and also the three-layer FRP splice. Fig. 26 revealed that the shear stress leveled off after about 0.9 in. (22.9 mm) of deflection, which is identical to deflection of three-layer wrap case. This could be due to internal pile failure, and test pile was not able to resist stress beyond 987 psi (6.81 MPa). It is interesting to note that the deflection of the pile spliced with six layers of FRP was only 0.51 in. (13.0 mm) at 613 psi (4.23 MPa), whereas 0.9 in. (22.9 mm) was the deflection for three-layered FRP-wrapped system at 613 psi (4.23 MPa) stress. The failure mode (Fig. 26) was ductile in the six-layer FRP wrap specimen, and the failure occurred in compression at the center of the splice (Fig. 27) with no zipping.

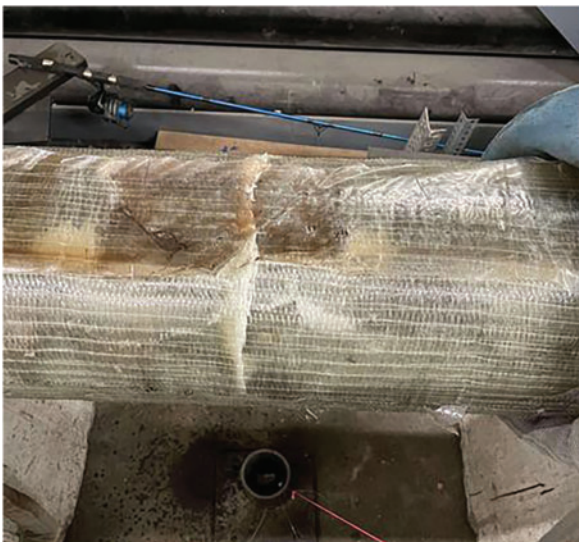
**Figure 27.** Compressive failure of fabric

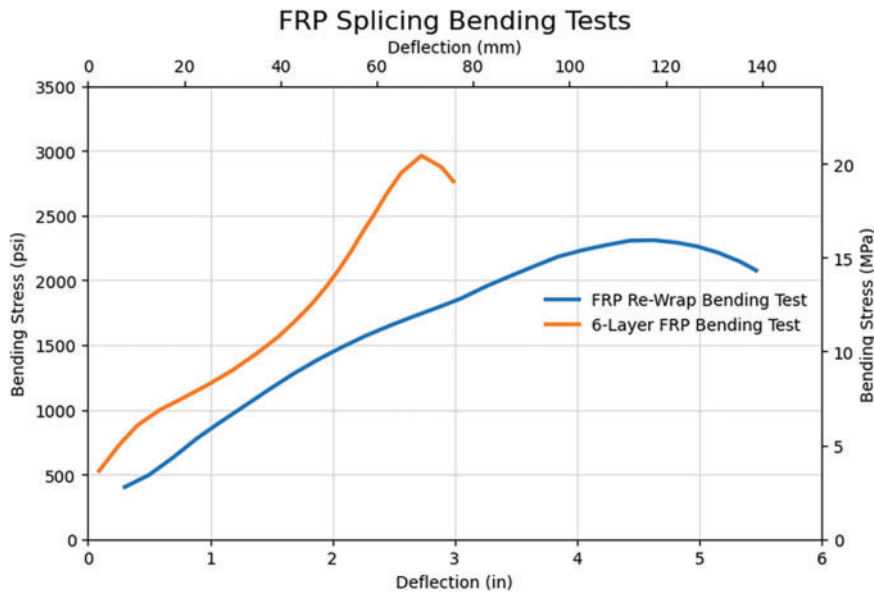
**Figure 28.** FRP rewrap bending stress versus deflection. FRP, fiber-reinforced polymer

Bending stress versus deflection plots for the repaired or rewrapped pile as well as the six-layer pristine specimen are shown in Fig. 28. The stiffness of rewrapped specimen was lower than that of the pristine three-wrap FRP-spliced specimens due to inadequate bending transfer across the

failed joint of the pristine three-wrap system. Large deflections from this test are attributed to already failed original splice with three-layered FRP wrap. With the three bottom layers having already failed, significant debonding between the splice mechanism and the pile is observed, resulting in larger deflections. Therefore, the bending capacity of the rewrapped systems is developed from the three additional (new) layers of fabric after initial testing to failure with three layers, and not six layers including original three layers.
